Charlottetown Thermal Generating Station Decommissioning Study

MARITIME ELECTRIC COMPANY, LIMITED
 CHARLOTTETOWN THERMAL GENERATING STATION, CHARLOTTETOWN, PEI
 2018 DECOMMISSIONING STUDY

MARITIME ELECTRIC COMPANY, LIMITED
 CHARLOTTETOWN THERMAL GENERATING STATION
 UPDATED PHASE II ENVIRONMENTAL SITE ASSESSMENT

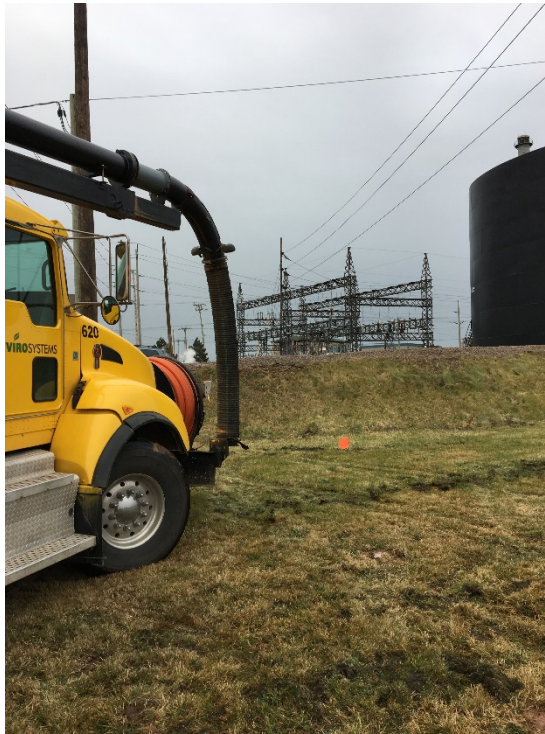
Photo 1 Hydroexcavating at MW-2, looking south.

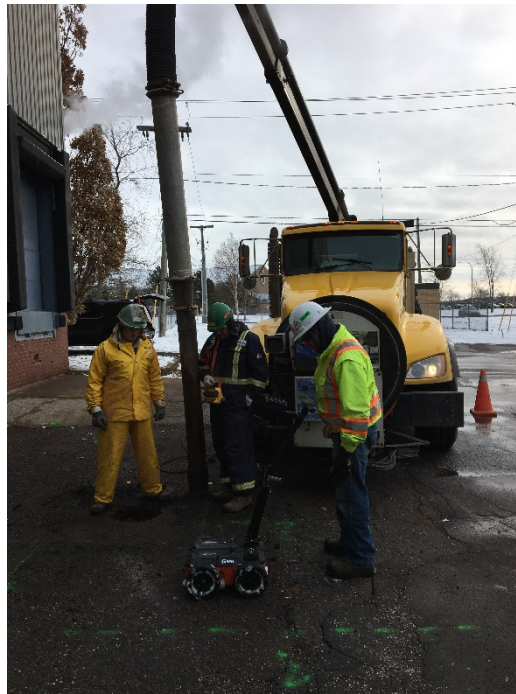
Photo 2 RL Dennis using ground penetrating radar to mark out utilities in the ground prior to hydroexcavating MW-4, looking southeast.

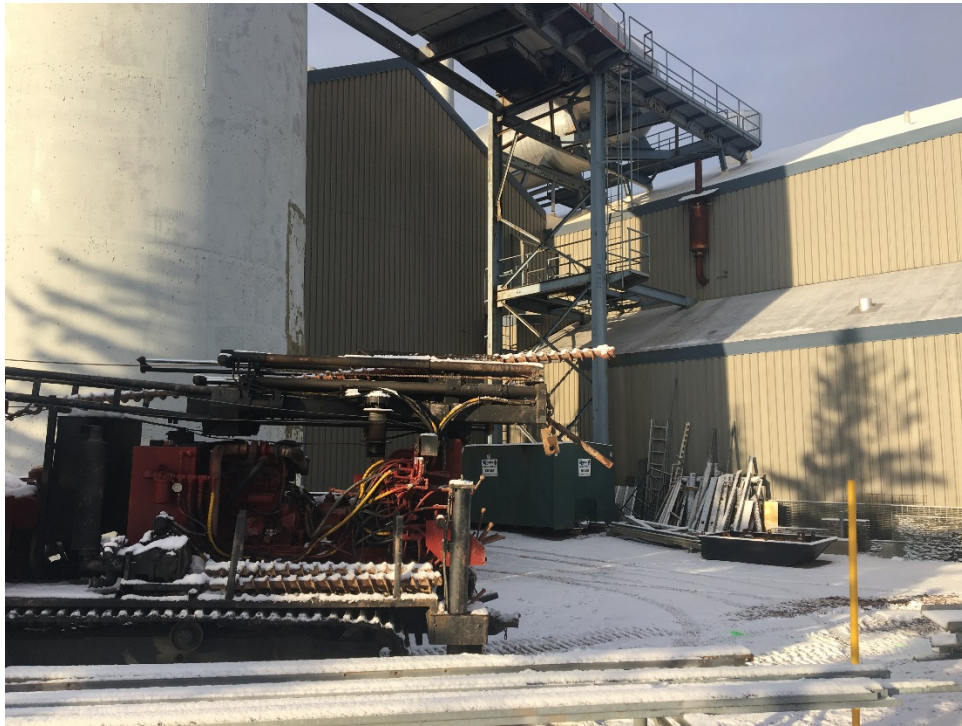
Photo 3 CME 55 track mounted drill rig setting up on MW-12, looking west.

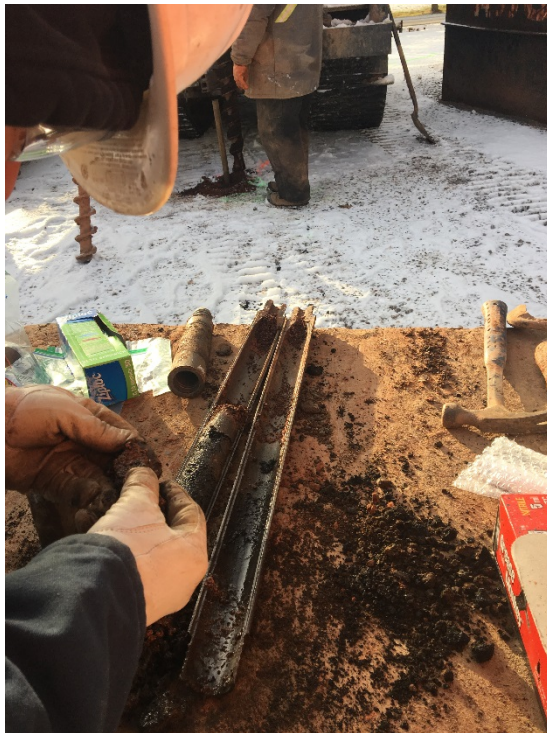
Photo 4 Geotechnical assessment of soil in split spoon from MW-12.

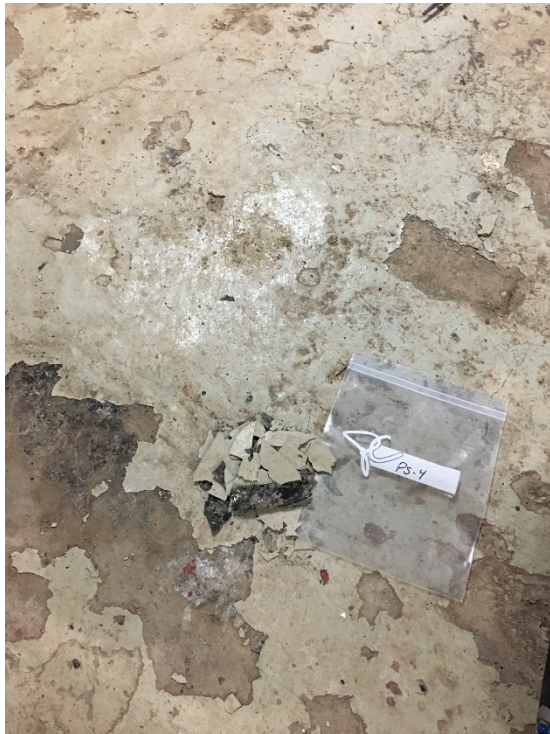
Photo 5 Paint sample PS-4 and sampling area. Concrete floor in CT3 BOP area basement.

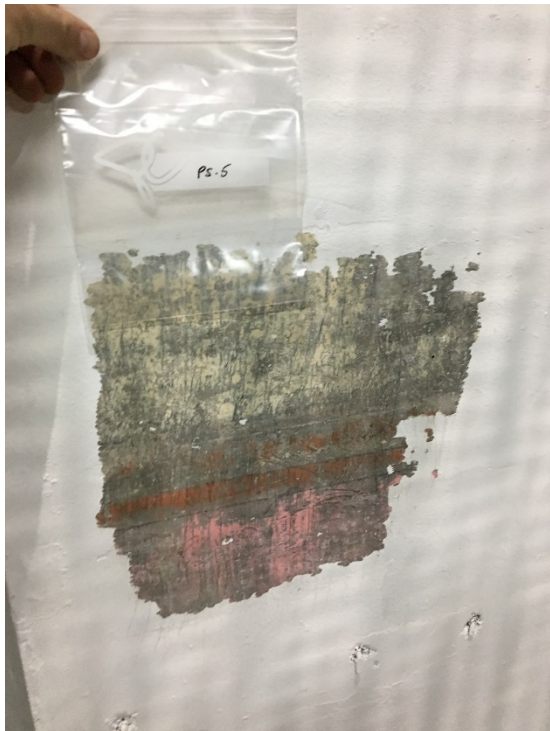
Photo 6 Paint sample PS-5 and sampling area. Concrete wall in CT3 BOP area basement.

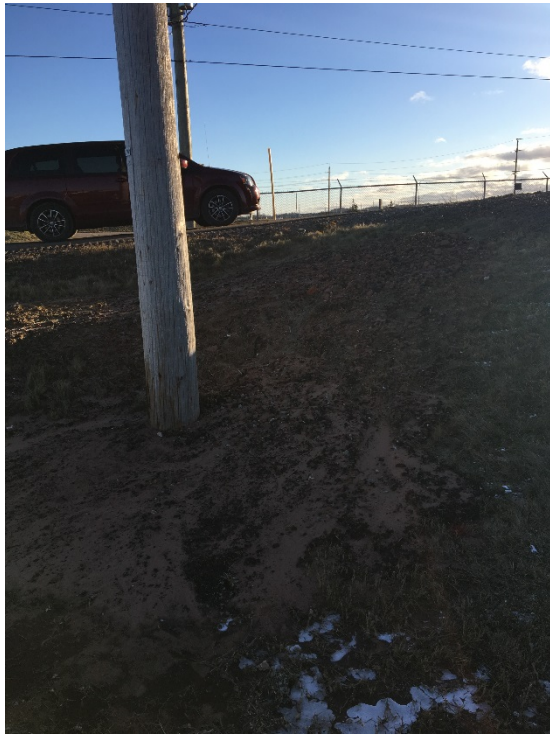
Photo 7 Spoil pile area (hydroexcavated material) located near MW-2, looking east.
